No.6

Business case #1 Commercial & industrial PV plant

- Location: N of Milan (45°N, 9° E)
- Plant description: 450 kWp on commercial warehouse, buildingintegrated PV (BIPV) plant.
- Connection to the grid: 2011
- Business model: Italian's feed-in tariff from 2011 (4th Conto-Energia): 0-43 €/kWh (for building integrated systems)

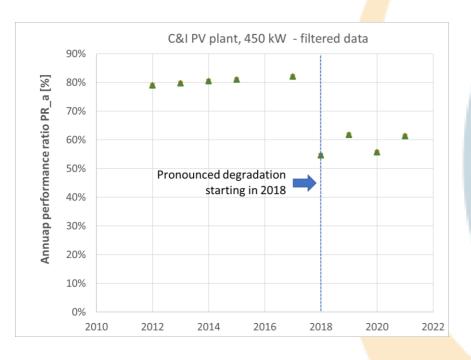
38.3 °C 43.3 IR ↓ 16.5

Thermography highlighted the presence of hot-spots in solar cells, that could be correlated to the presence of sever cracks by performing UV-F (UV-Fluorescence) imaging. Likely the presence of cracked cells can be traced back to a **severe hail event** happened in summer 2018 (please note that none of the modules had broken glass covers). The plant's underperformance went long unnoticed, leading to ~25% lower annual revenues. The on-site inspection was first performed in 2021.

- -Full repowering restoring the initial nominal power (i.e. 450 KWp).
- -Full module substitution with newer technology reducing the occupancy of the plant by 25%. The freed space has been used to install more PV increasing self-consumption.
- -The generous feed-in tariff (0.43 €/kWh) and the time left for the incentives (9 years) fully justified economically the intervention.
- -No legal claim was started against the manufacturer for the damaged modules and the non-compliance with warranties. The module manufacturer was not existing any longer.
- -To much time had passed for filing a cla<mark>im with t</mark>he insurance company.
