Business case #2 Utility-scale PV plant

- Location: Piedmont (44°N, 8° E), Italy
- Plant description: ~4.5 MWp utility-scale ground mounted.
- Connection to the grid: mid 2016
- Business model: power purchase agreement (PPA)

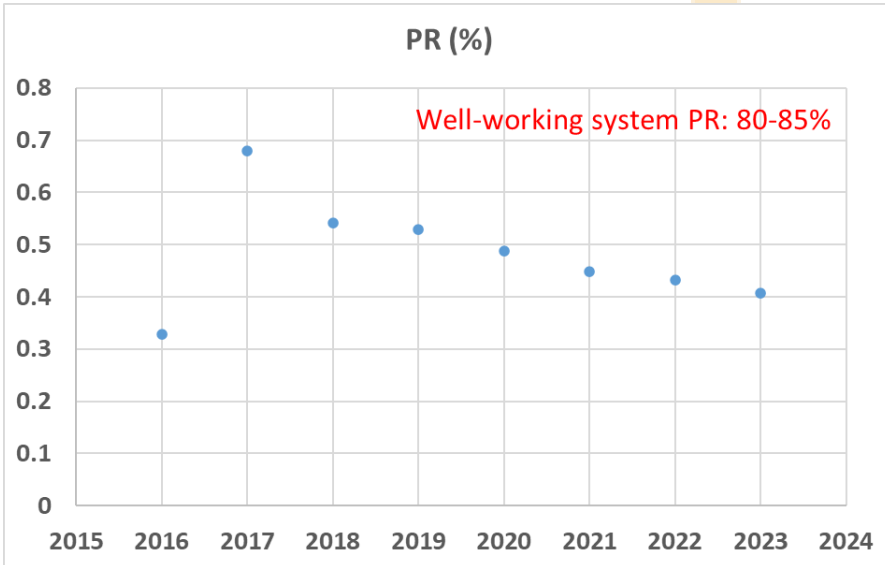
The annual performance PR of the PV plant in 2017 is ~70% (a relatively low initial value compared to a conventional PR of ~80-85% for a state-of-the-art plant). Since then, the PR is decreasing annually by more than 5%.

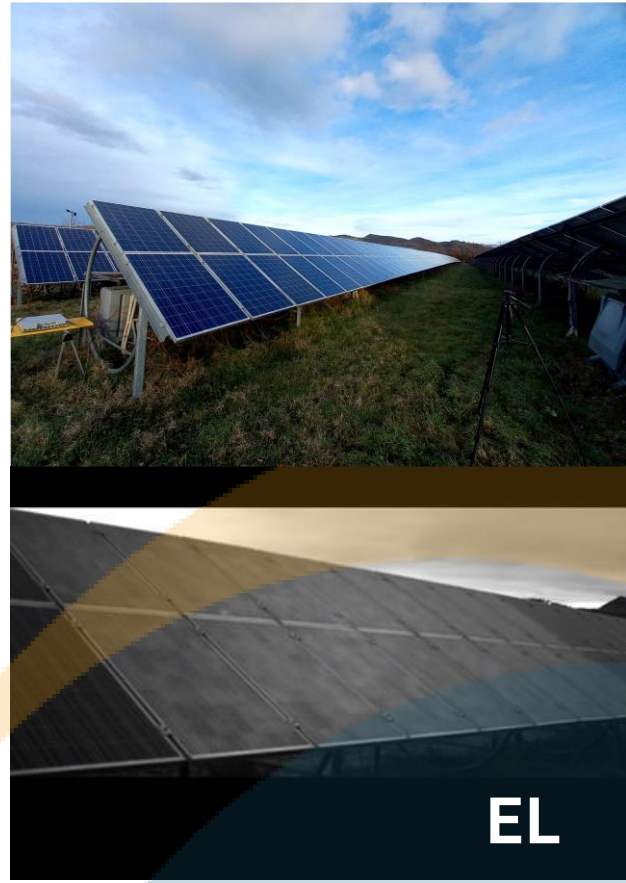
String-level electroluminescence (EL) allows detecting underperforming PV sub-arrays. On **site IV curve tracing** - followed by **laboratory testing** on selected PV modules - allowed ascribing the severe decrease of the modules to a sub-standard quality of the modules. The series resistance of the module is bad and increases over time leading to a severe underperformance of the modules. Root-cause: most likely a poor ribbon soldering process in manufacturing.

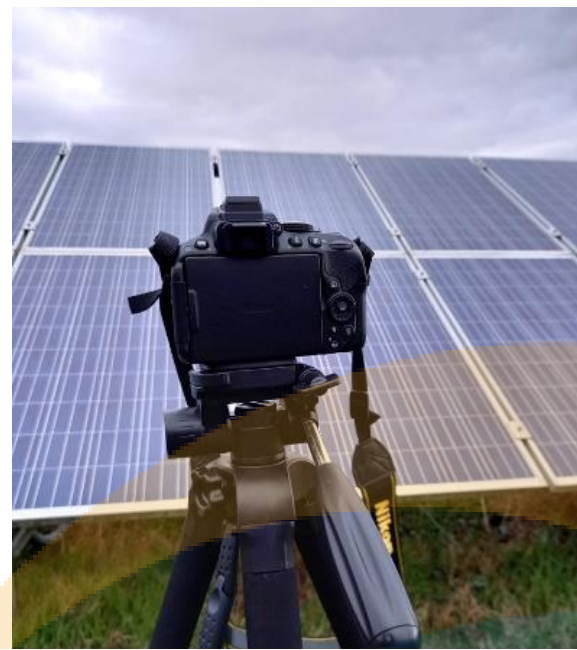
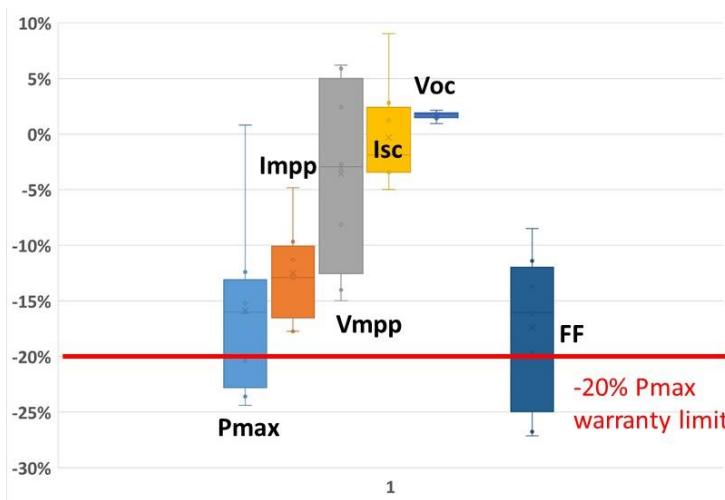
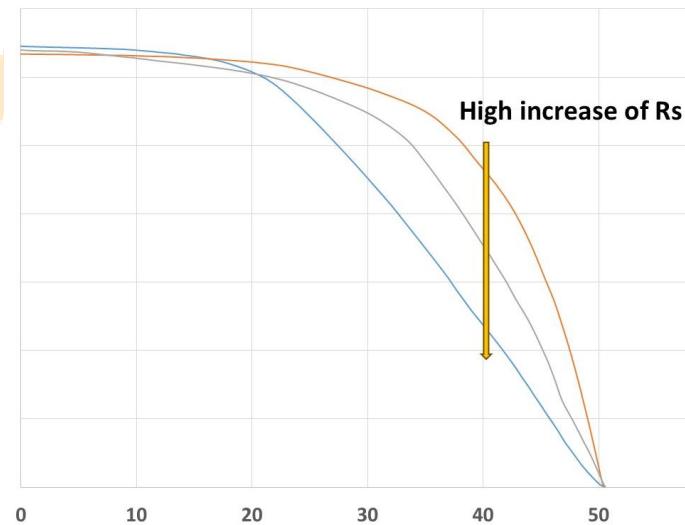
Average power (Pmax) loss of 20 selected modules flashed at an ISO 17025 accredited partner laboratory. Most degradation can be attributed to a strong reduction in the FF due an increased series resistance R_s (R), mostly attributable to poor soldering contacts of the ribbons in solar cells.

- Full repowering of the underperforming PV strings
- Start of a legal claim against the module manufacturer for performance warranty infringement and sub-standard module quality.
- Substitution of the underperforming PV modules (~0.85 MWp) after reaching an agreement between parties.
- Pls note: the PV modules were certified products according to the relevant industry standards.
